<b>Project Name</b>	<b>McElhanney Project Number</b>	<b>Client Project Number</b>
Project Name	2451-XXXX-XXX	XXXXX
<b>Contractor</b>	<b>Client Name</b>	
Full Contractor Name	Client Name	
<b>Report Date</b>	<b>Prepared On</b>	
June 3, 2025	June 3, 2025	
<b>Arrival Time on Site</b>	<b>Departure Time from Site</b>	
8:00am	5:00pm	
<b>Weather (AM)</b>	<b>Weather (PM)</b>	
10°C, Sunny	20°C, Cloudy	
<b>Prepared By</b>		
Report Writer, Credentials

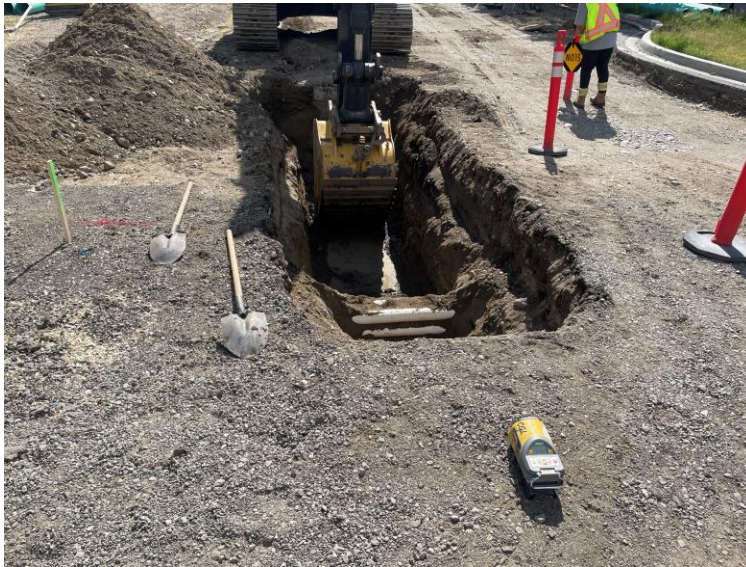
**Photo 1**

Item #	Note
1	During the installation of the new solid 300 mm PVC storm stub from Richter St to existing drywell DW1, CGL confirmed that there was a direct conflict between the existing shallow utility duct bank along the east side of Richter St and the new storm main: <ul style="list-style-type: none"> <li>McElhanney noted that the new 300 mm PVC storm main should be installed under the existing duct bank to ensure minimum cover is achieved, with a maximum slope of ~2% to prevent the future extension of the PVC main into Richter St from ending up too deep.</li> <li>CGL noted that they installed the new storm stub with an invert of 343.71 m at DW1, and an invert of 343.62 m at the end of the stub in Richter St (resulting in a slope of ~1.3%).</li> <li>CGL's surveyor collected as-built data for the installed storm stub.</li> <li>Refer to the first photo in Section 8 of this report.</li> </ul>

Excavation of the ground to find some utilities, and there's shovels on the ground and a pipe laser.
